WoolCo Services, LLC

General Information

BUILDING ADDRESS: 1204 East 29th St.

INSPECTION DESCRIPTION: Customer: Judy Payne

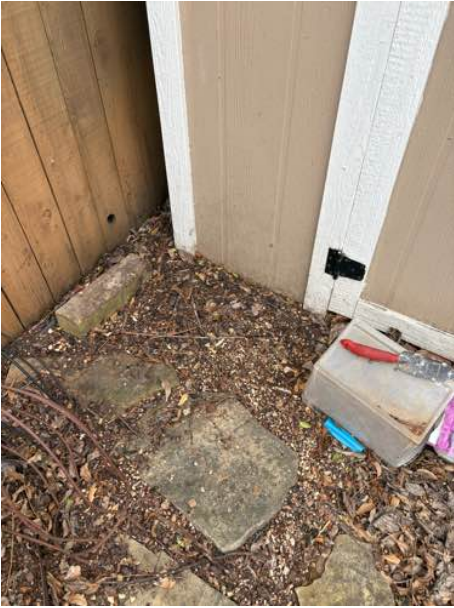
SHED / OUTBUILDINGS Inspected

Observed NE wall of wood shed in contact with ground. recommend removal of dirt and leaves(see pic).

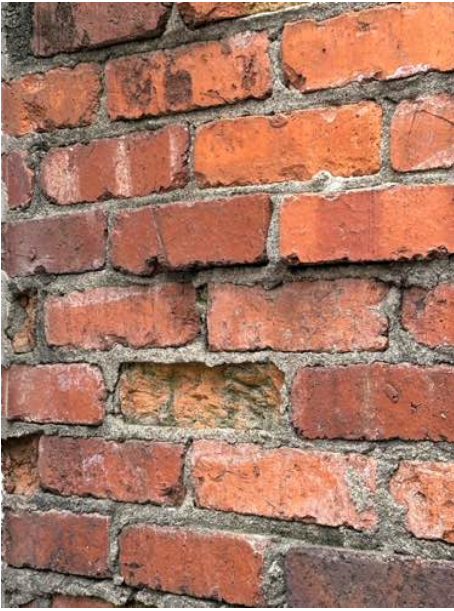
CHIMNEY Inspected

Some brick Spalling on chimney. Recommend further evaluation by qualified brick mason.(see pic)

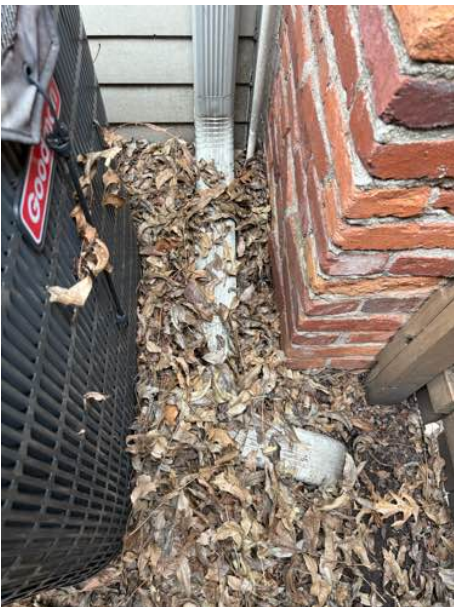
GUTTERS AND DRAINAGE Inspected

Recommend cleaning gutters. Down spouts are in ground so proper drainage was not determined. Noticed a smashed down spout at ground on East side of house next to A/C.(see pic).

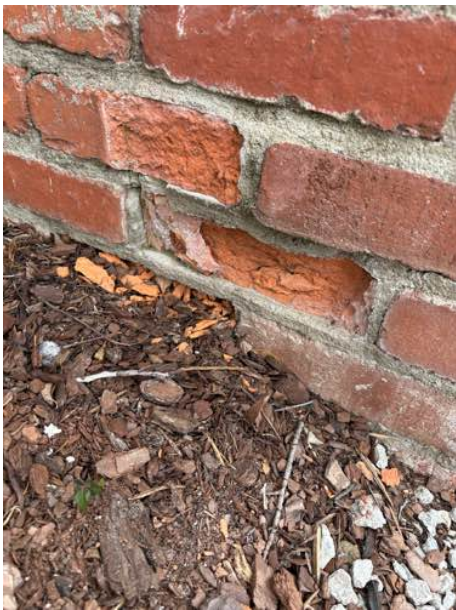
SIDING CONDITION Inspected

Fiber cement siding appears in good condition. Some spalling noticed on brick veneer mainly due to moisture and no weep holes in brick structure.

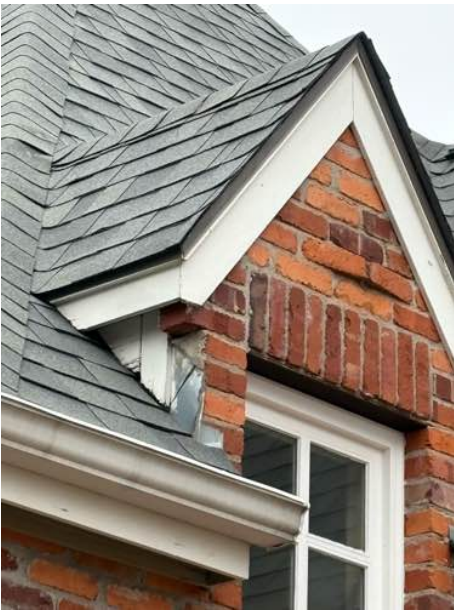
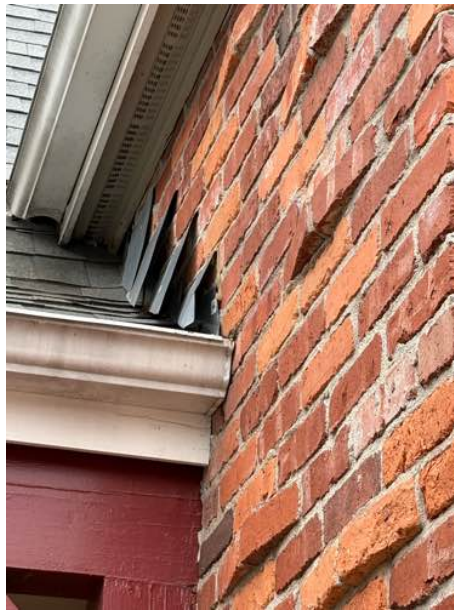
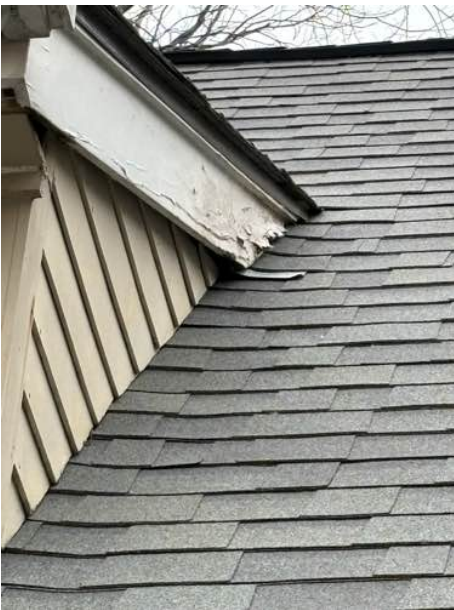
FLASHING Inspected

Flashing at front dormers above garage and above front door.

Recommend licensed roofing contractor for further evaluation. (See pics)

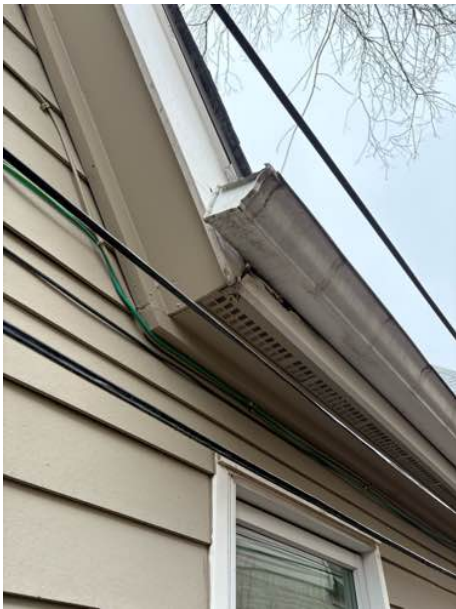
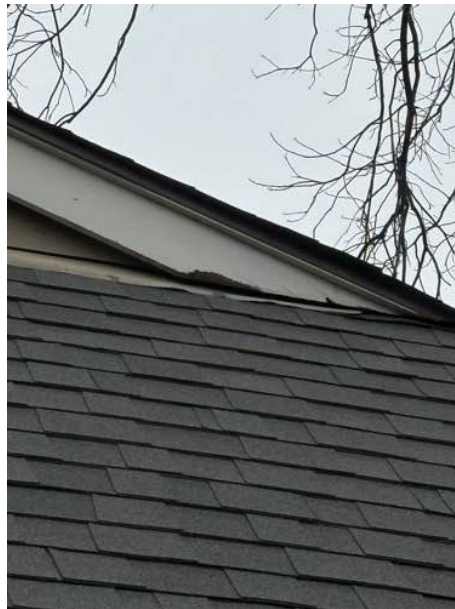
EAVES Inspected

Fascia at second floor back of house deteriorated. Fascia at roof/ gutter on east side of house deteriorated . Recommend handy man or capenter(see pics).

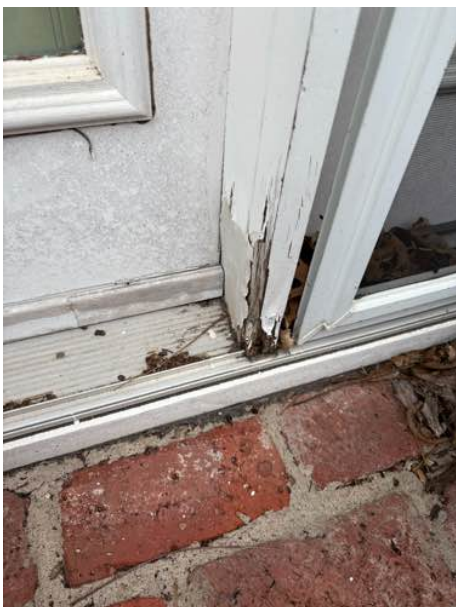
TRIM Inspected

Trim at back door off master. Recommend carpenter for repair (see pics)

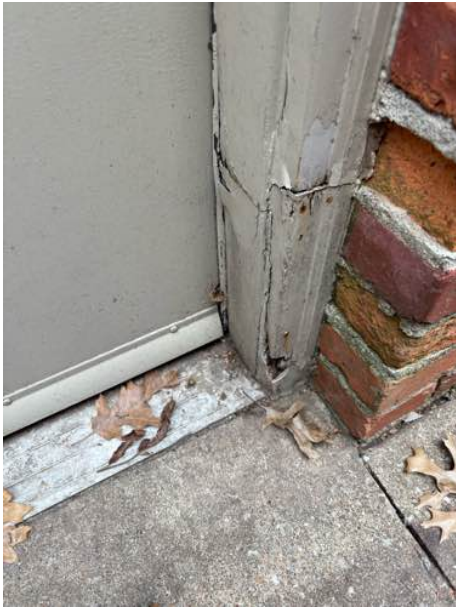
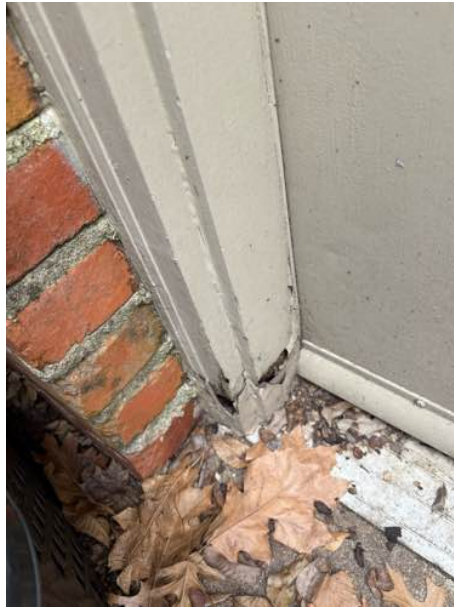
EXTERIOR DOORS Inspected

Door at master bedroom and door from garage on East side of house deteriorated at frame on bottom (see pics) recommend carpenter.

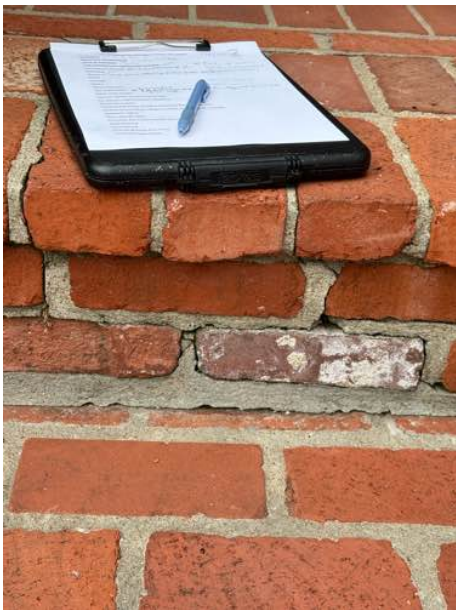
STOOP / PORCH Inspected

Some brick spalling and mortar deteriorated. Recommend brick mason for tuck pointing.(see pics)

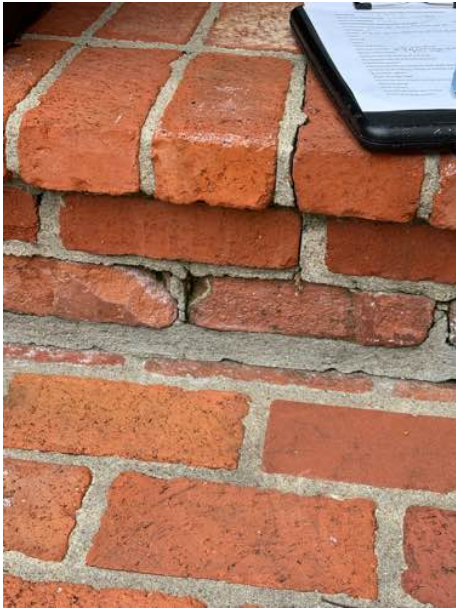
STEPS Inspected

Recommend Brick tuck pointing on front steps as reported (see pics)

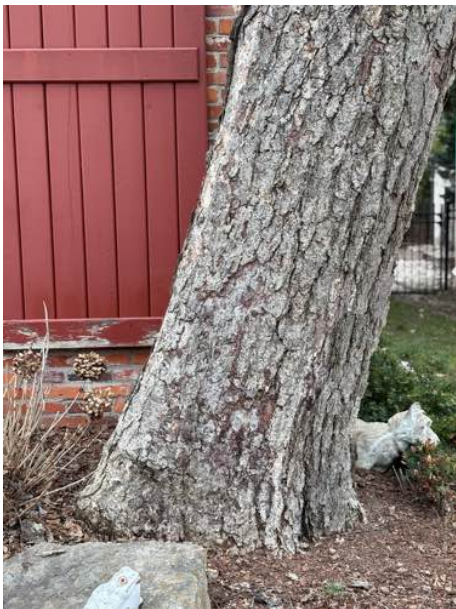
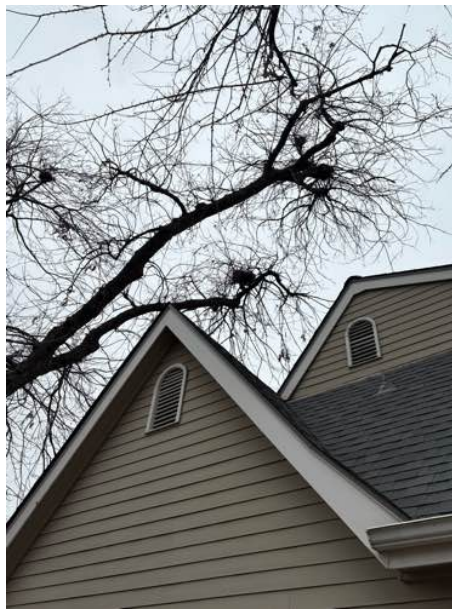
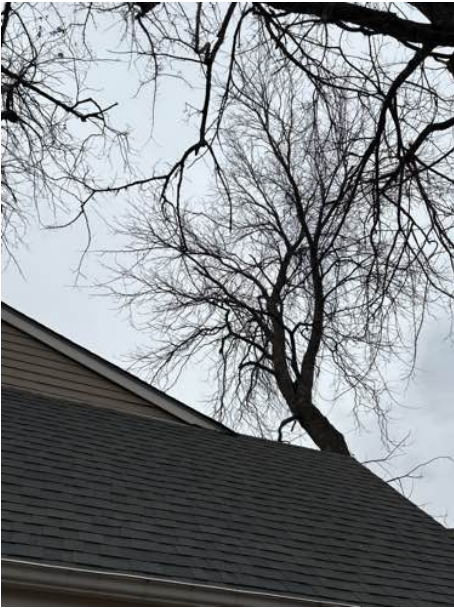
VEGETATION Inspected

Trees overhanging house in a few places. Recommend removal by professional tree service. This is a safety issue and dangerous.(see pics)

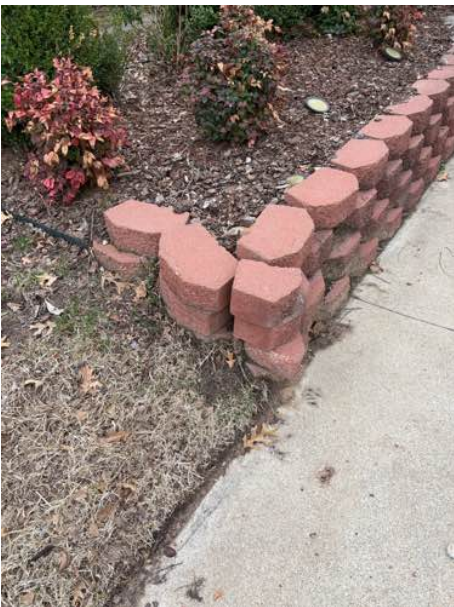
RETAINING WALL Inspected

Small stacked landscape block retaining wall. Recommend maintenance by landscape contractor.(see pic)

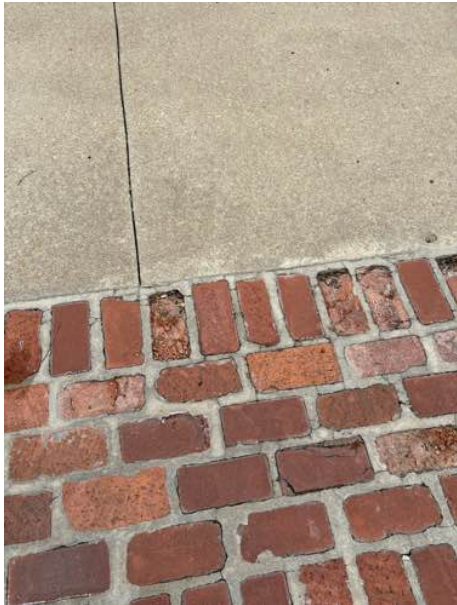
DRIVEWAY Inspected

Some brick spalling in driveway (see pics) recommend brick mason for further evaluation.

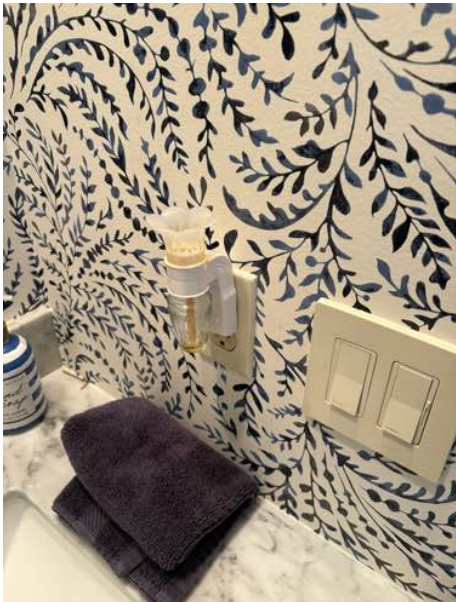
OUTLETS Inspected

GFCI receptacle recommended. Recommend licensed electrician (see pics)

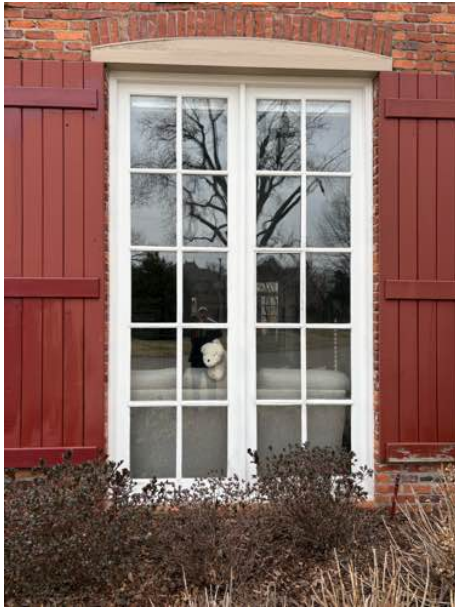
WINDOWS Inspected

Some maintenance recommended on large front window. Recommend qualified window contractor and painting contractor.(see pics)

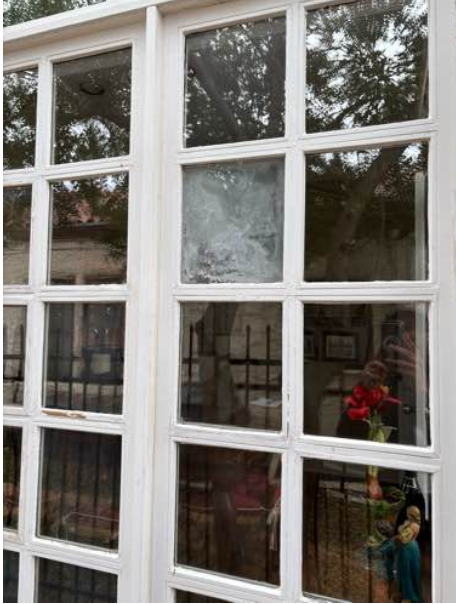
WINDOWS Inspected

Some deterioration observed and broken seal in window pane at dining room .Recommend qualified window contractor for further evaluation (see pics)

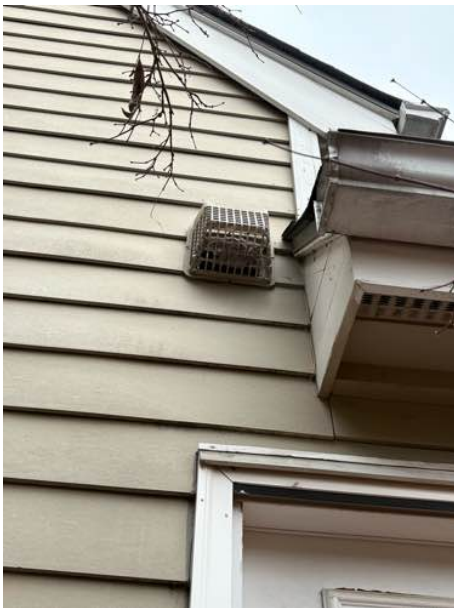
VENTILATION Inspected

Recommend cleaning dryer vent annually. It is a long horizontal run to outside vent.

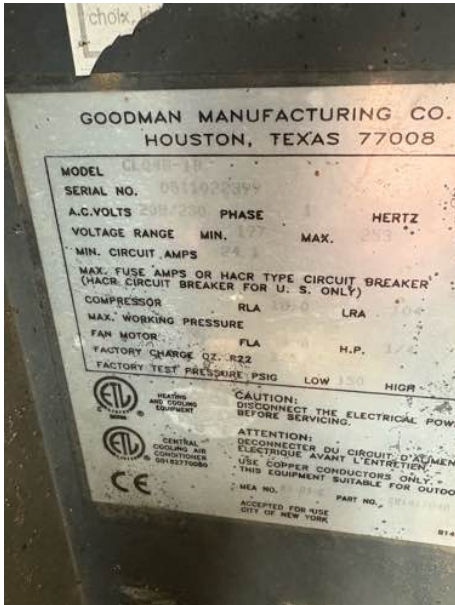
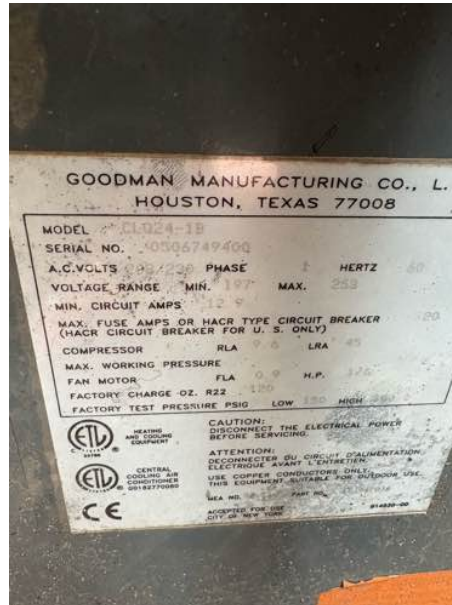
COOLING SYSTEM Inspected

Could not test due to temperature 41deg F. One 4 ton compressor and one 2 ton compressor. Outside on east of house. Recommend annual HVAC inspection and maintenance. These systems run on R22 refrigerant which is discontinued. But there is a substitute refrigerant still in use.

Could not test due to temperature 41deg F. One 4 ton compressor and one 2 ton compressor. Outside on east of house. Recommend annual HVAC

inspection and maintenance. These systems run on R22 refrigerant which is discontinued. But there is a substitute refrigerant still in use.
